PIANC De Paepe-Willems Award Winner 2018

SYSTEM OF INSPECTION AND DIAGNOSIS FOR PORT STRUCTURES USING UNMANNED BOAT

Keywords: piled piers, inspection, diagnosis, unmanned boat, 3-D modelling

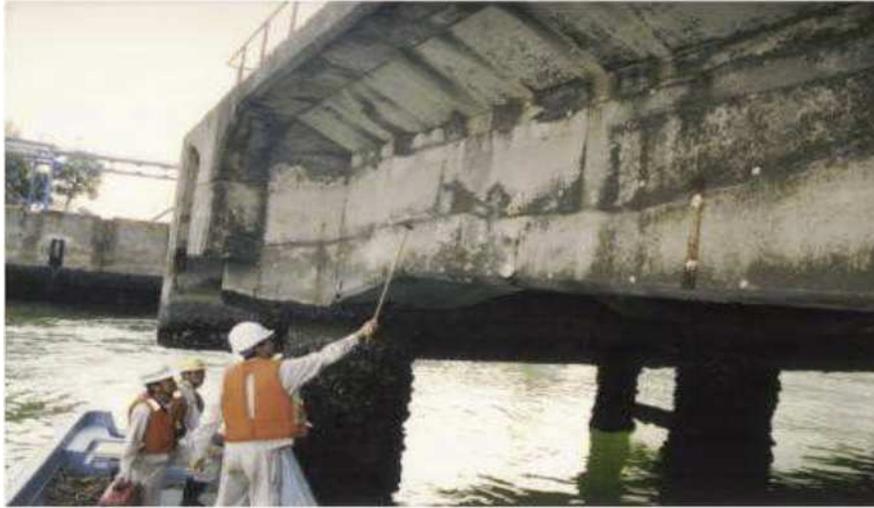
Visual inspection of the bottom parts of the superstructures of piled piers in Japan is commonly conducted by a specialist on board a small boat, as shown in Figure 1.1. The specialist ascertains the degree of degradation by visual observation from the boat, fully utilising his knowledge. Inspections frequently overlap with the time when ships are moored or when there is an ebb tide. Sometimes, inspection may be conducted in the night depending on the tide level. Consequently, the inspection needs considerable time and costs. As the person engaged in a prolonged investigation is affected by waves, including wakes during inspection, excessive physical stress is also an issue. In addition, since the boat used in the investigation accommodates two people – the boat operator and the inspector – even a small boat needs a certain size. This prevents the boat from entering narrow areas, such as near the aprons, preventing inspections from being adequately performed. Owing to the long service period of the port facilities, there are cases in which either the maintenance and management data are inappropriately stored or the objective data themselves do not exist, hindering smooth handover of the inspection and diagnostic tasks. Moreover, the judgment of the necessity for repair and selection of a repair method are based on the four-stage standard criteria in Japan (a, b, c, and d), but the results of grading are in most cases biased due to the subjective opinion of the inspectors.

Figure 1.1: Investigation of the undersurface of the superstructure of a piled pier (conventional method)

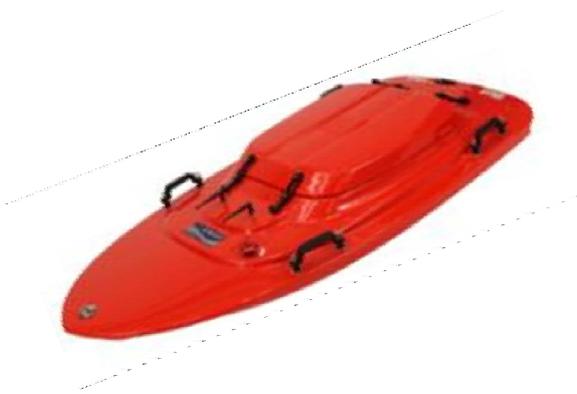
The small unmanned boat selected for this system is produced in the USA and has been previously used in many studies focusing on flow-rate observation and sounding of rivers and the like. Before the devices were mounted, the boat measured 1.8 m long, 0.9 m wide and 0.35 m high and had a mass of approximately 25 kg. The boat has two thrusters at the stern that are powered by batteries stored inside the boat.

Figure 2.2: Unmanned boat (before mounting the devices)

To perform an efficient inspection, various devices were installed on the unmanned boat. Figures 2.2 and 2.3 show the unmanned boat before and after mounting the devices, respectively. Upon mounting the devices, the boat became 2.2 m long, 1.1 m wide and 0.65 m high and had a mass of 57.5 kg. It was able to enter below a piled pier as long as the distance between the undersurface of the superstructure of the piled pier and the water surface was approximately 80 cm or more.

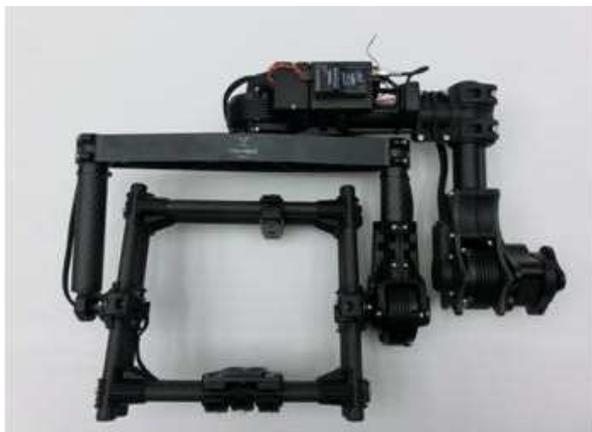
At an early stage of development, a camera was directly mounted on a radio-controlled boat, resulting in the captured images being blurry due to the boat's motion under the influence of waves and the inability to focus. To capture stable images using the image-shooting camera, the camera was mounted with the aid of a high-performance three-axis control-type gimbal (shaking-suppression device), which automatically regulates each pitch, roll and yaw motion. This arrangement holds the mounted camera in a particular direction. Figure 2.4 shows a photograph of the gimbal used herein and Figure 2.5 shows a photograph of the gimbal mounted on the boat.

Figure 2.4: Photograph of the gimbal

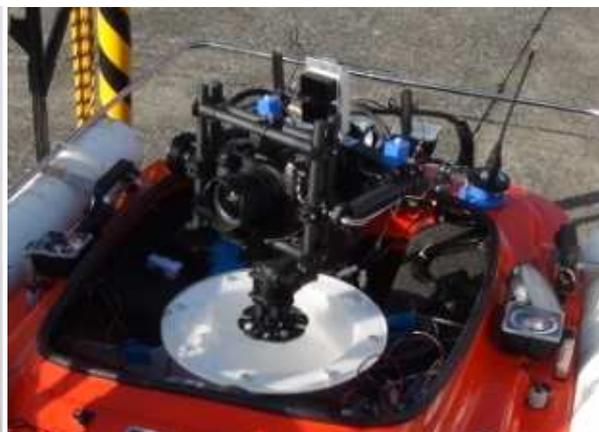
Figure 2.5: Photograph of the gimbal with image-shooting camera setup

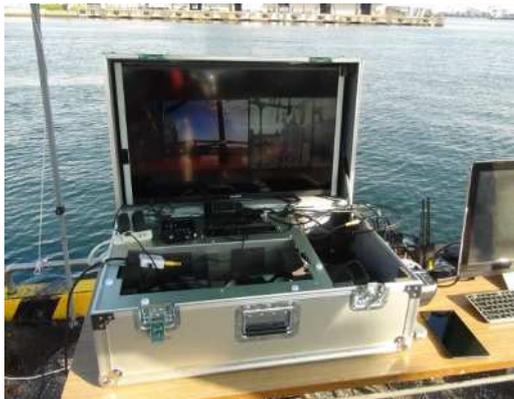
The images captured by the boat operation and image-shooting cameras are transmitted by their respective transmitters and are received at the monitor placed on the pier, as shown in Figure 2.8. By observing the images on the monitor screen, the boat operator drives the boat and the inspector controls the gimbal. Figure 2.9 shows an image captured by the boat operation camera during an investigation.

Figure 2.8: Image monitor

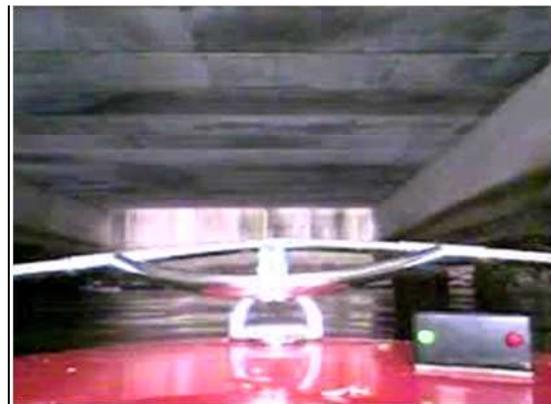
Figure 2.9: An image captured by the boat operation camera

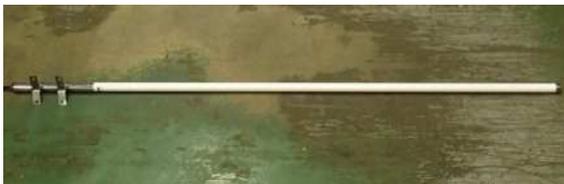
In addition to the abovementioned normal radio, the boat operation radio system includes an emergency radio, which uses the 350-MHz frequency band. While the frequency of the emergency radio tends to have a signal lag compared to that of the normal radio, it can be used in emergencies when communication with the normal radio fails during boat operation. Figures 2.12 and 2.13 show the external antennas for the transmitter and receiver of the emergency radio, respectively.

Figure 2.12: Transmission antenna of the emergency radio

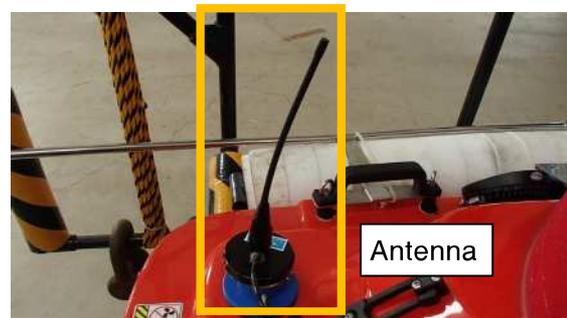
Figure 2.13: Reception antenna of the emergency radio

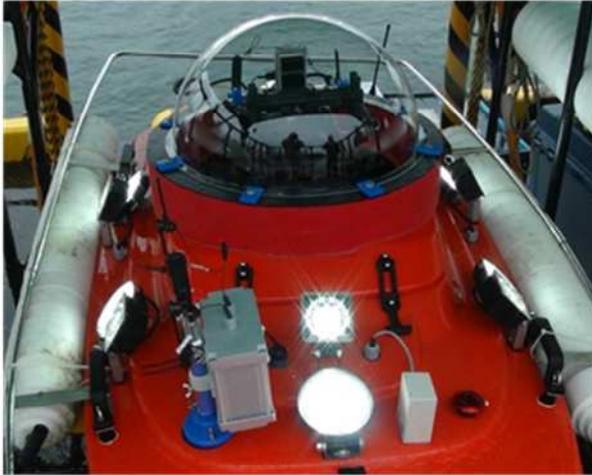
Thus, LED-lamps were installed on the unmanned boat to provide illumination suitable for capturing pictures. Figure 2.14 shows a photograph of the unmanned boat with the LED-lamps illuminated and Figure 2.15 shows a diagrammatic arrangement of the LED-lamps. Each LED-lamp can be turned on and off individually via remote radio operation. This arrangement enabled secure image shooting with illumination, as required for conducting the investigation.

Figure 2.14: LED-lamps when active

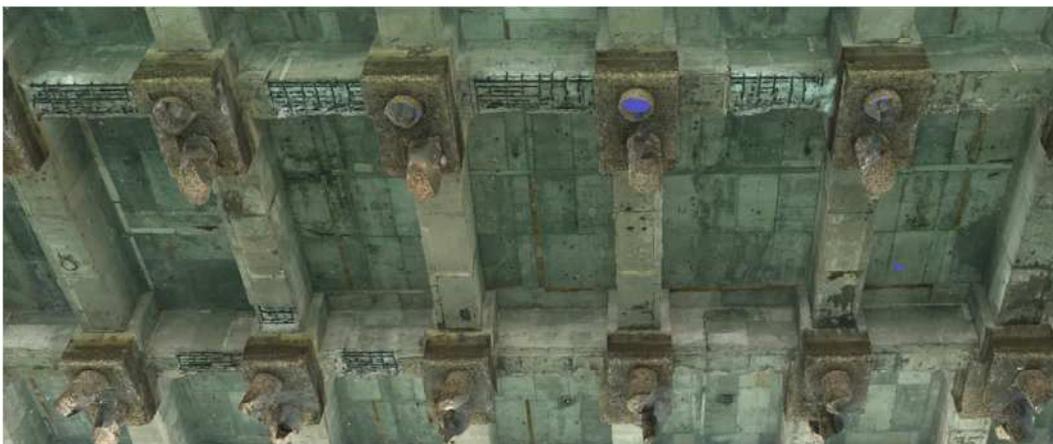
A 3-D model covering about 1,600 m² of the planar portion of the pier was created using still pictures extracted from 4K (8.29 million pixels) recorded during the trial as shown in Figures 4.4 and 4.5. The 3-D model was created from the images of 2,064 sheets with intervals of about 1 sheet/s using the SfM/MVS software. The 3-D model enabled the determination of the positions of the part members and degradation. The traveling speed of the unmanned boat estimated from the images was about 50 cm/s, from which the overlap rate of the adjacent continuous images along the advancing direction was computed to be about 84 % for slabs.

Figure 4.5: 3-D model of the undersurface of the superstructure of the piled pier (close view)
